INTERNATIONAL SEMINAR ON APPLICATION OF
ADVANCED TECHNOLOGY IN SLOPE ENGINEERING

The Latest Technical Information on Mechanically Stabilized Earth Wall in Japan

~ Countermeasure study for heavy rain disasters ~

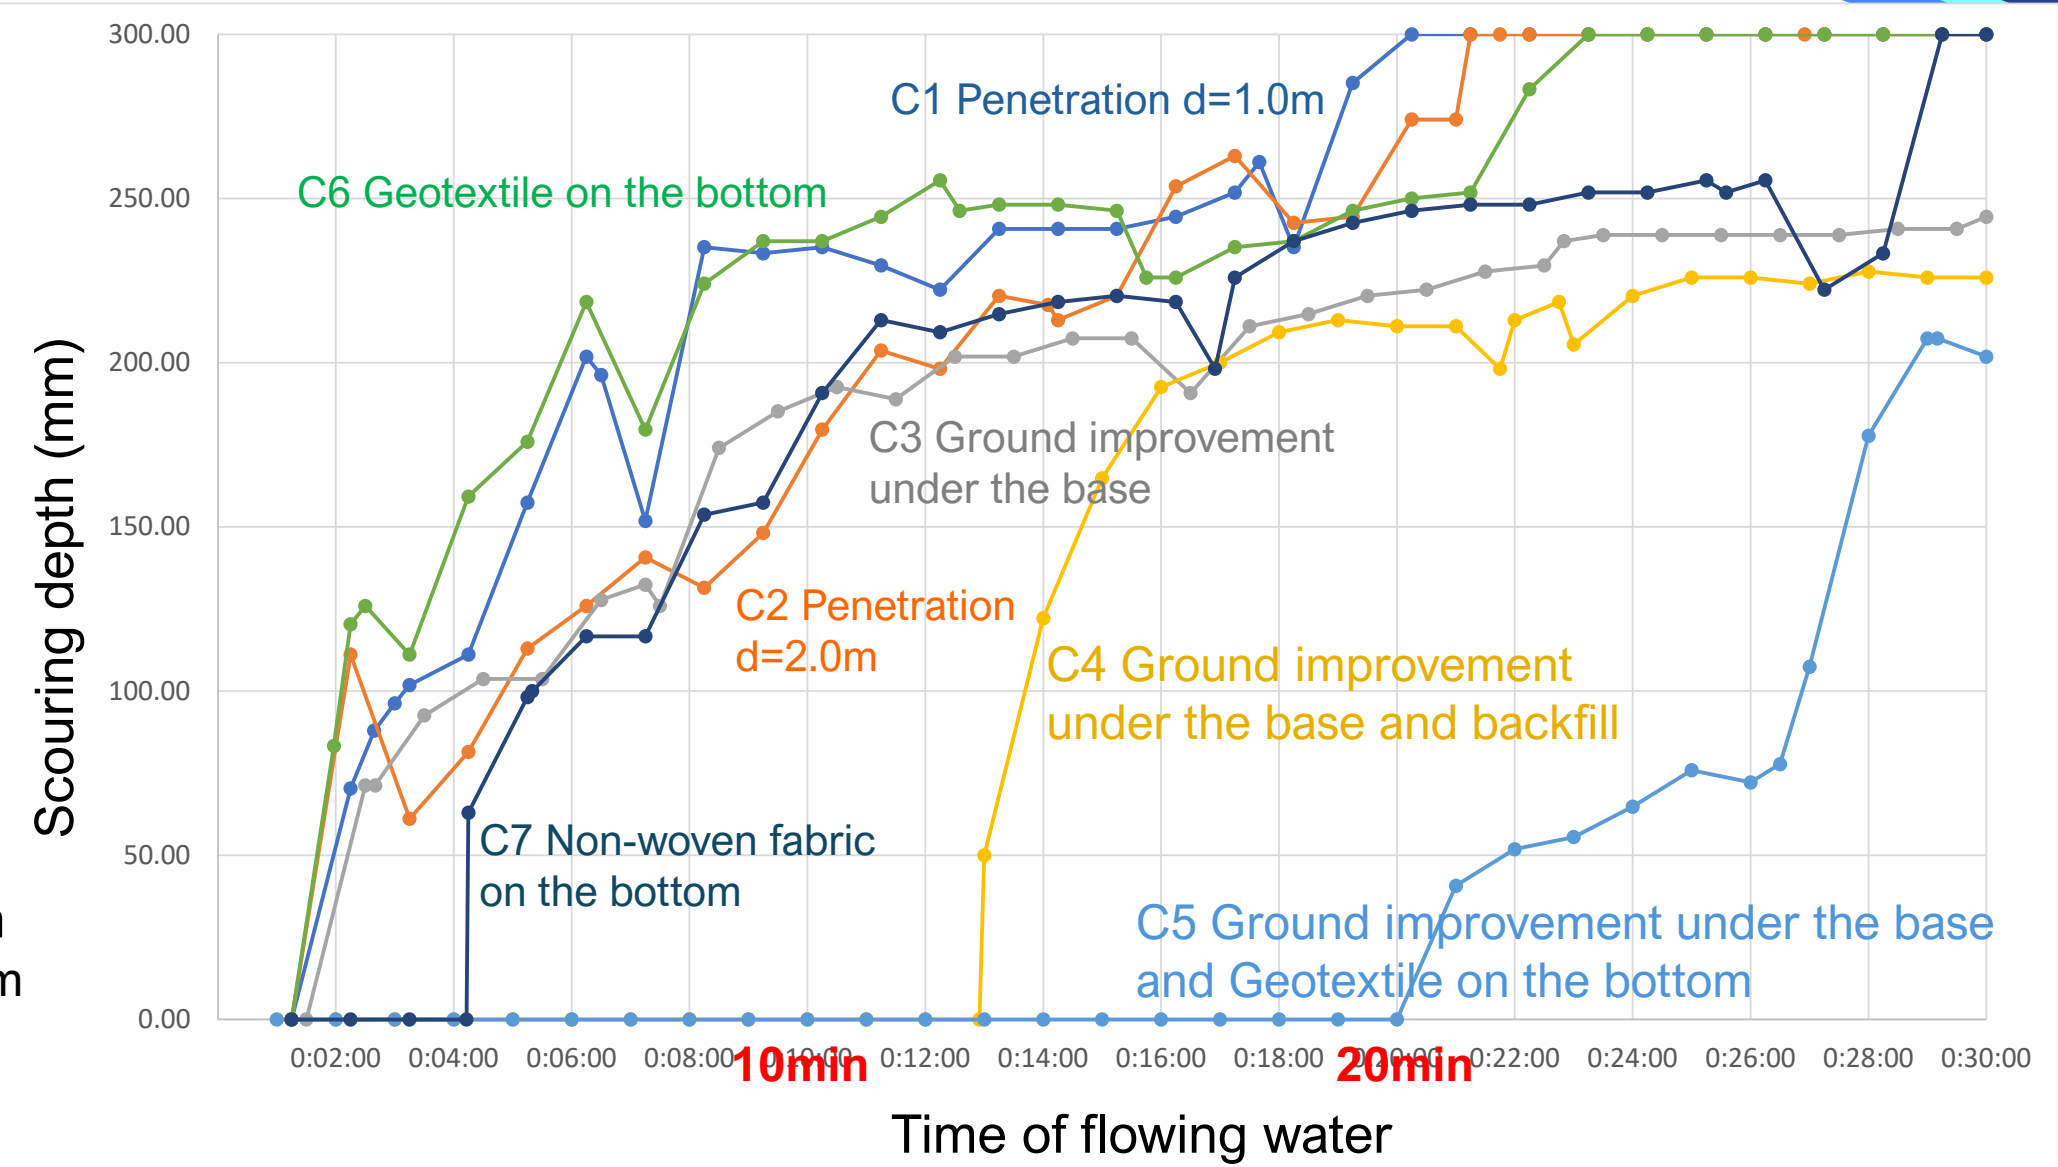
Results

- Ground improvement was effective against scouring.
- In the case where **both ground improvement and geotextile** are used together, the effect against scouring was became higher.
- Geotextile alone was not effective in controlling leakage due to deflection caused by the weight of the backfill.

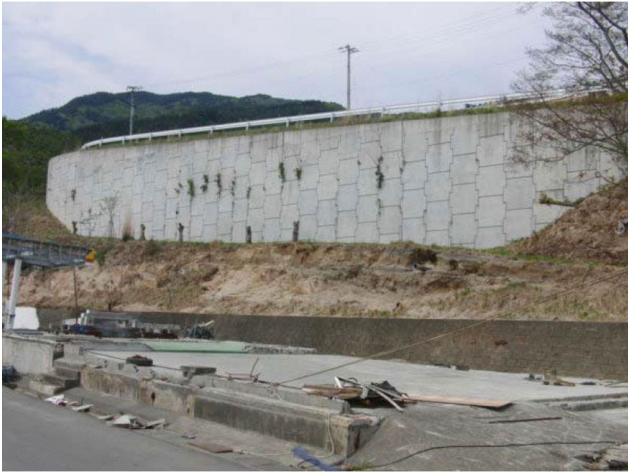
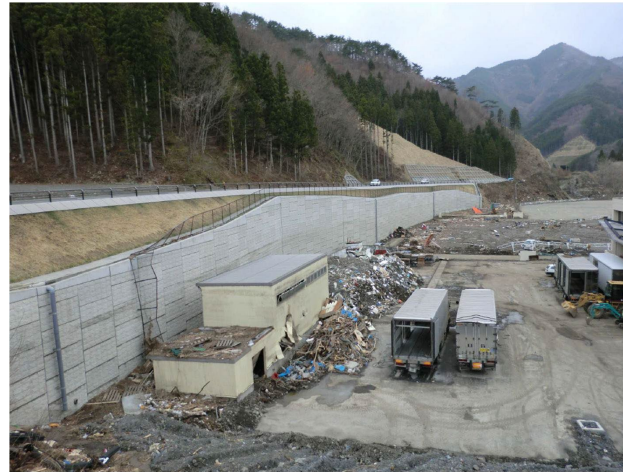
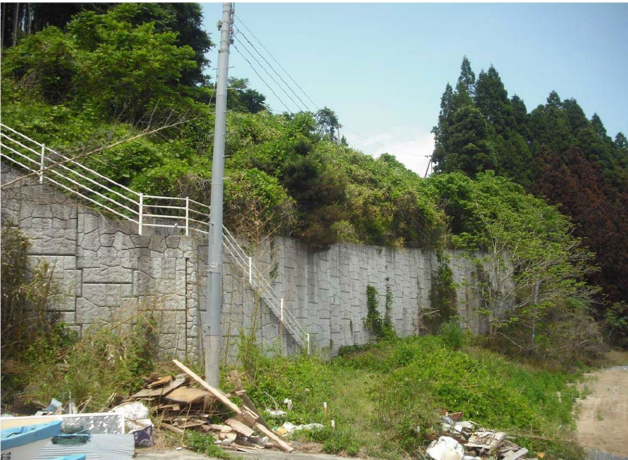
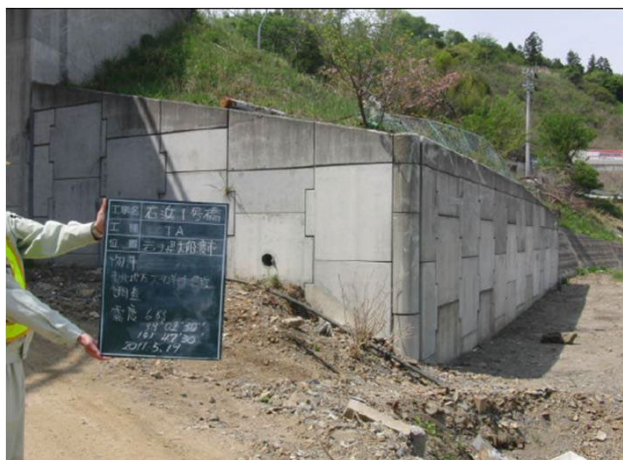
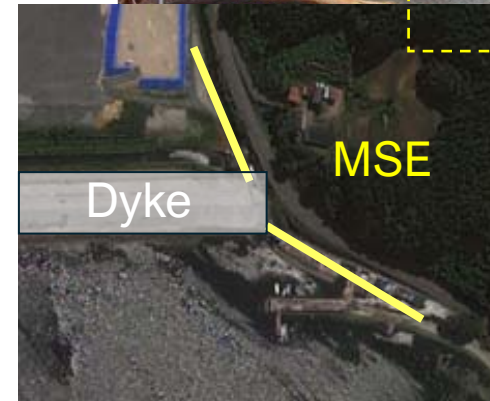
In the 2011 Tohoku earthquake, infrastructure was severely damaged by the earthquake and by the tsunami. Most of the MSEs were sound against both disasters. But a few sites were damaged by the tsunami due to some factors.

The dyke collapsed, opening the connection and causing internal erosion.

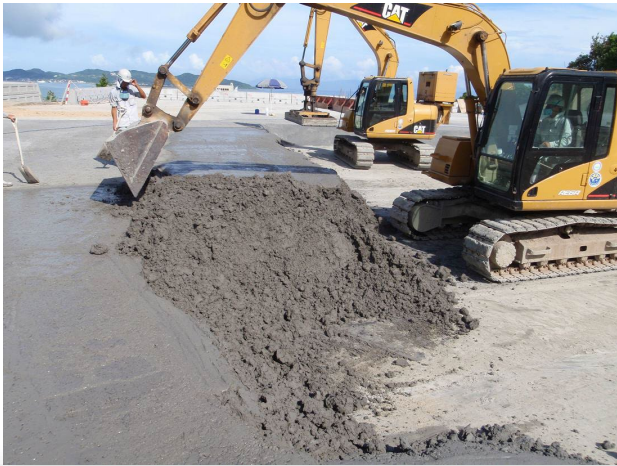
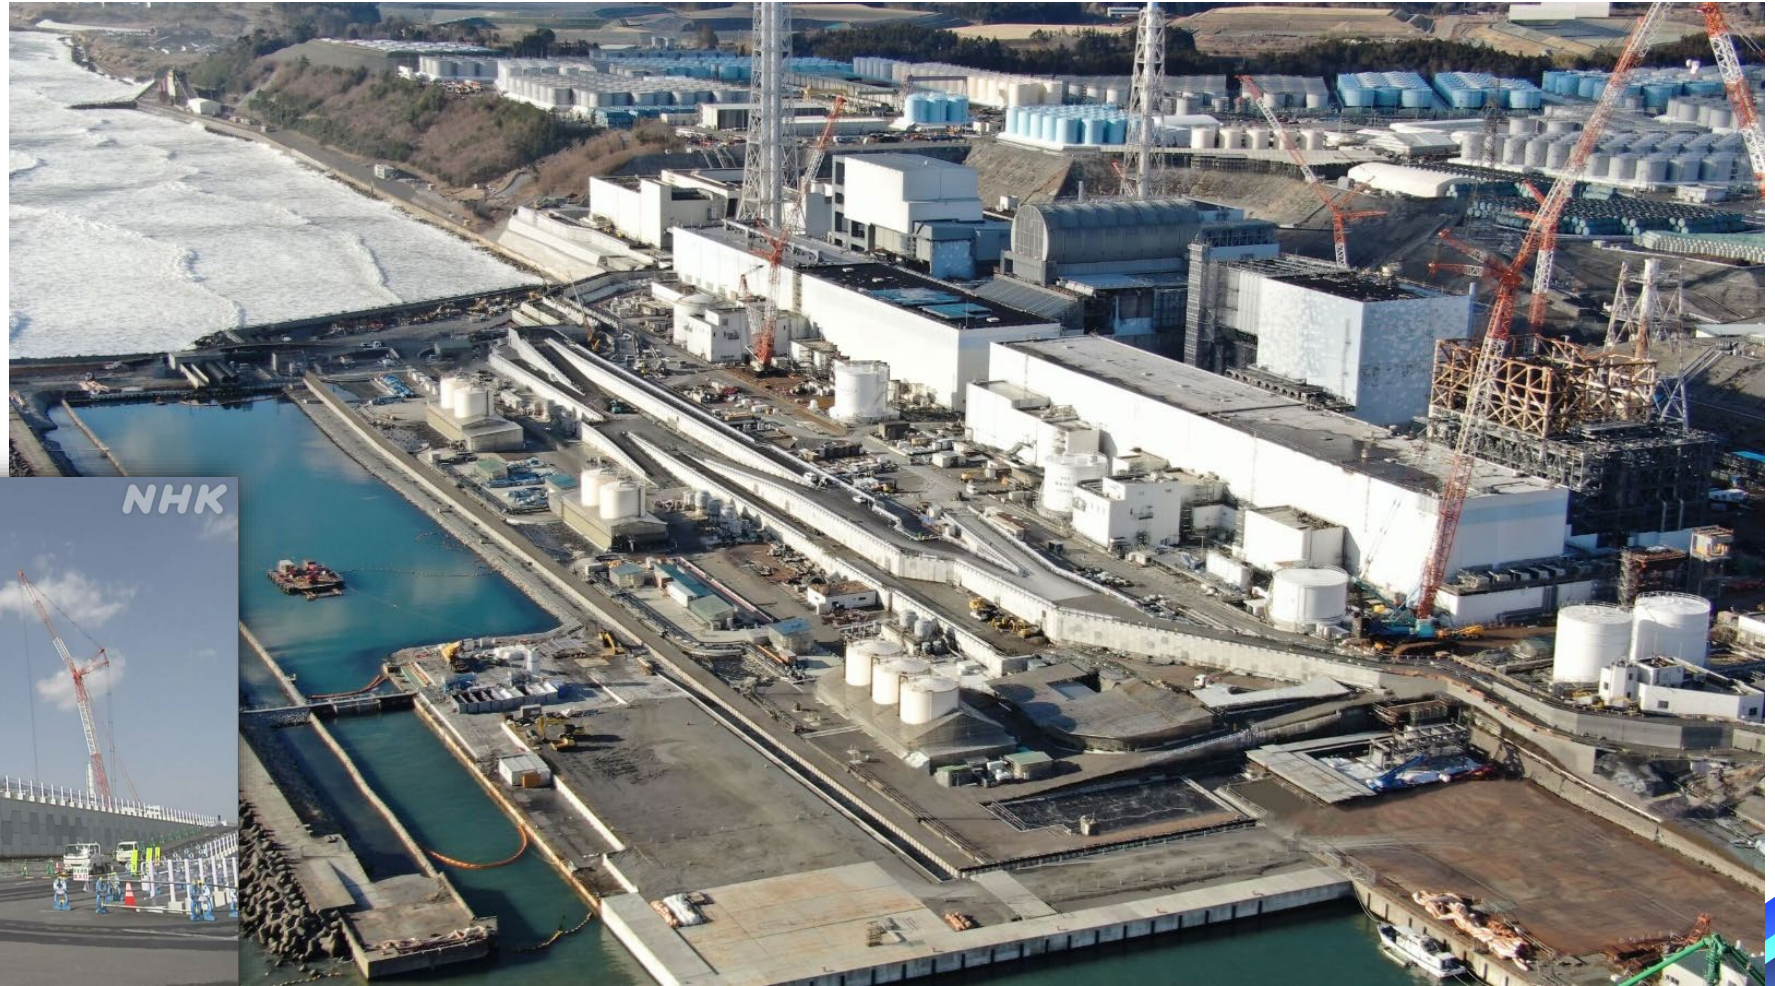
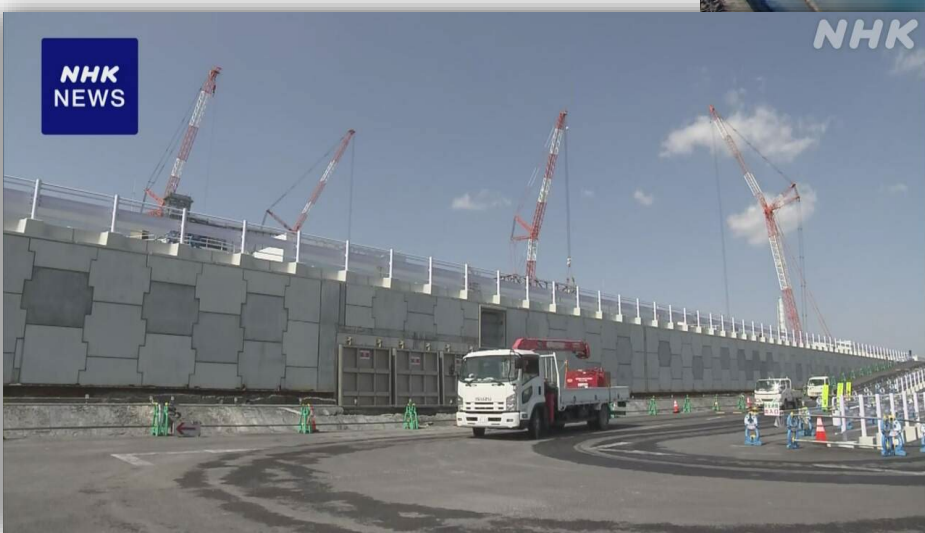
MSE was adopted for the seawalls of Fukushima Daiichi Nuclear Power Plant based on its results of short damage from tsunami. Ashcrete was used for backfill material.

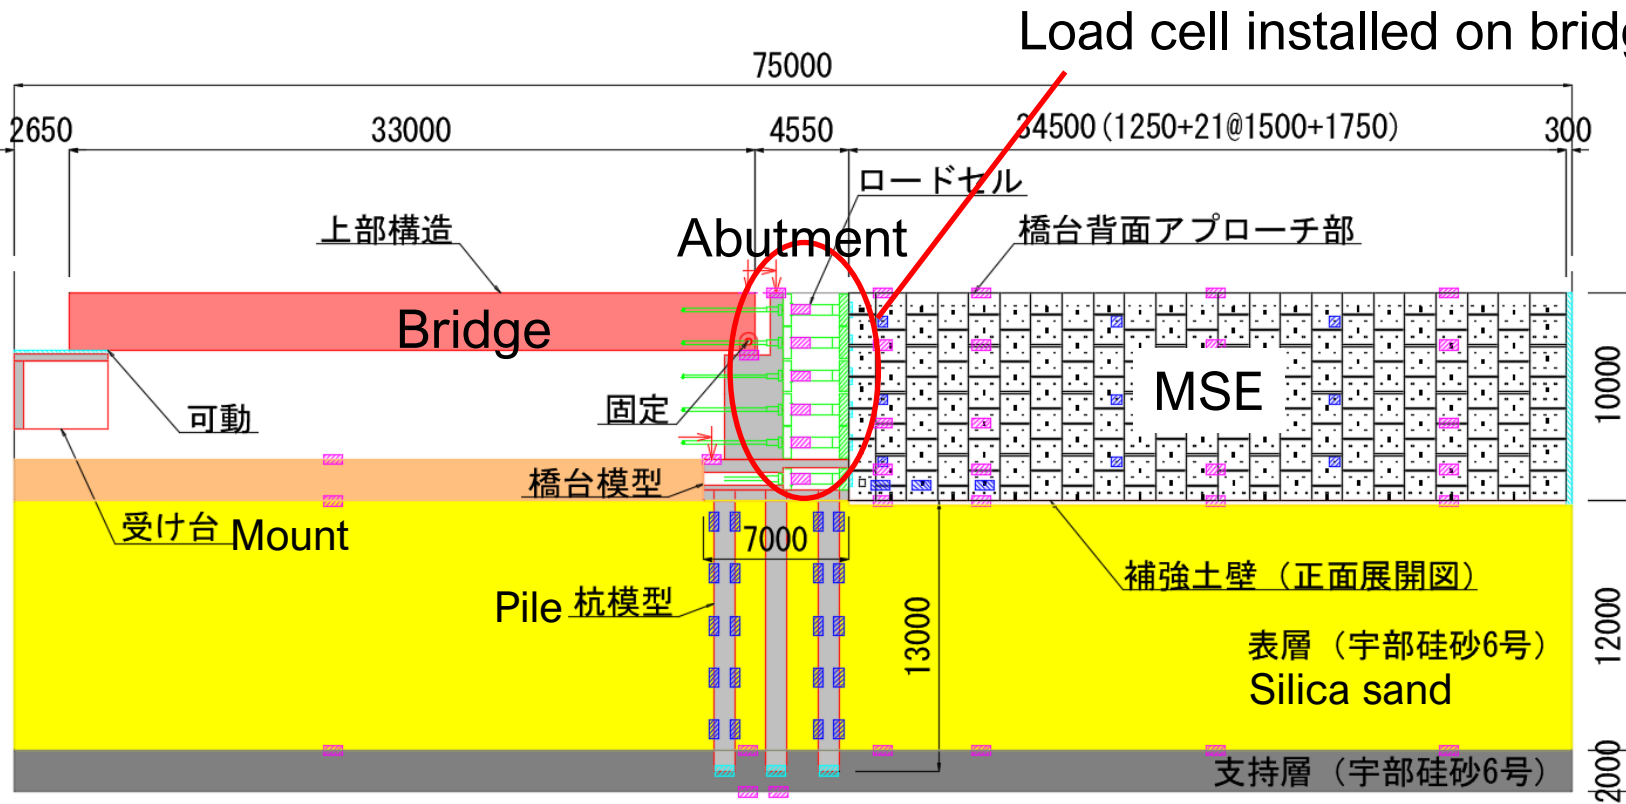
Dynamic centrifuge model experiment (1/50 model, full-scale H=10m)

Shaking conditions . . . Large-scale earthquake (Hyogo-ken Nanbu earthquake 1995)

3 cases : Unreinforced embankment, MSE (steel strip) and geotextile on back of abutment.

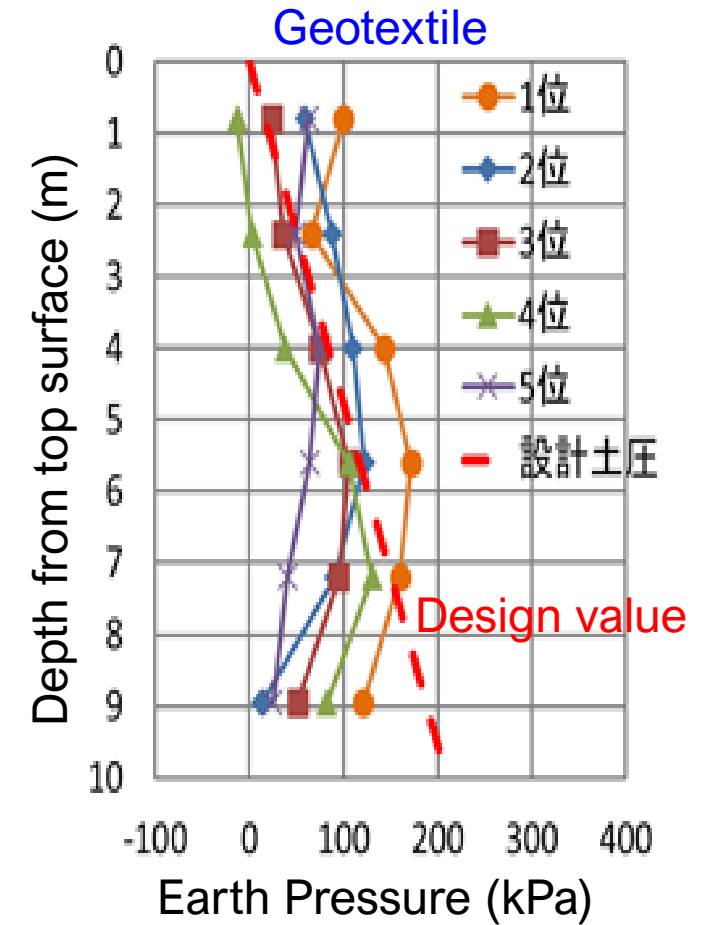
Distribution shape of top 5 earth pressure positions in time history

No significant difference in soil pressure distribution shape between MSE (steel) and other two and each earth pressure was similar to the design value

- There is no significant difference between unreinforced embankment and MSE in the distribution shape of earth pressure acting on the abutment during a large earthquake.
- When reinforced soil is applied to the back of the abutment, the same **earth pressure as that of the embankment should be considered.**
