## Observation case study of landslide caused by the 2024 Noto Peninsula earthquake

**Eight-Japan Engineering Consultants Inc.**

In Japan, a number of landslides occurred due to the Noto Peninsula earthquake on January 1, 2024. In this presentation, we will introduce a case survey of one of the landslides due to the Noto Peninsula earthquake, in which we conducted a field survey, Laser profiler investigation and installed GNSS observation equipment to observe the landslide.

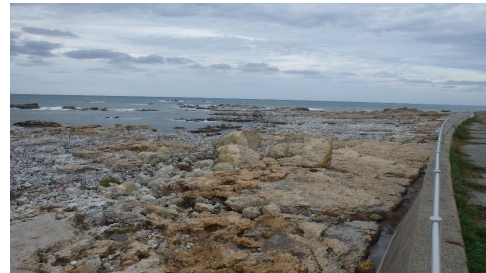
Fig. Earthquake-induced coastal uplift in the area around the epicenter (Taken October 29, 2024)

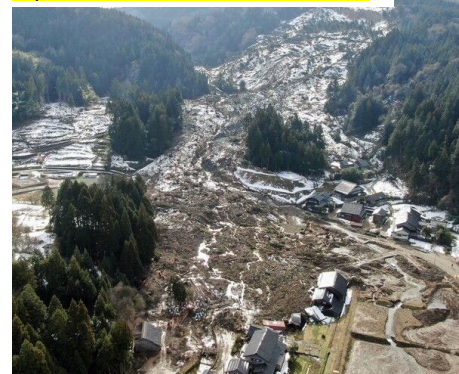
Fig. panoramic view of the landslide

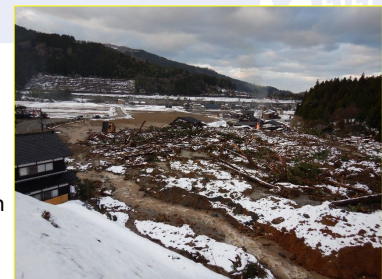
Terminal and Fluidization parts

Lower parts

upper parts

Minor scarp
