# The Record of the Natural Disaster and the Traditional Monument —Case of Nankai Earthquake and Sediment Disaster of Hiroshima

• **Hiroaki MATSUGI**      **Fukken Co., Ltd.**

INTERNATIONAL SEMINAR ON  
APPLICATION OF ADVANCED TECHNOLOGY IN SLOPE ENGINEERING  
HANOI, 2025

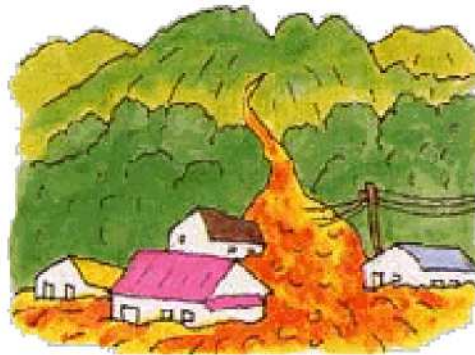
② Debris flow

土石流

【土石流の前兆現象】

- 山鳴りがする。
- 川の流れが濁り流木が混ざっている。
- 雨が降り続けているのに川の水位が下がる。

Heavy rain influences

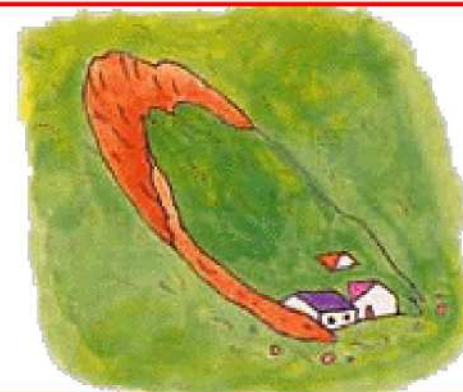
③ Land slide

地すべり

【地すべりの前兆現象】

- 斜面から水がふき出す。
- 地面にひび割れができる。
- 沢や井戸の水が濁る。

Groundwater influences

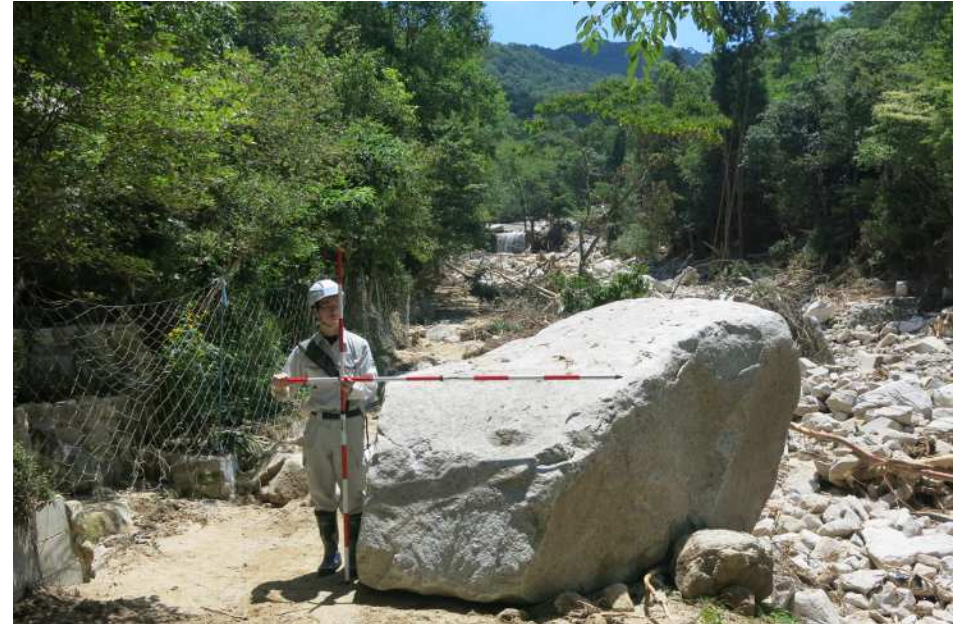
The edge of the dam destroy

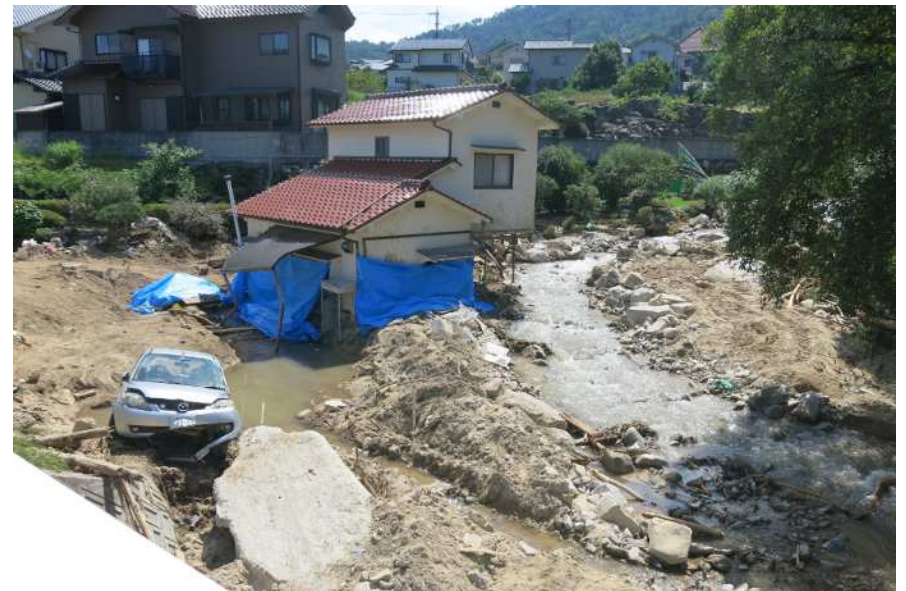
The house and car near  
the river destroys

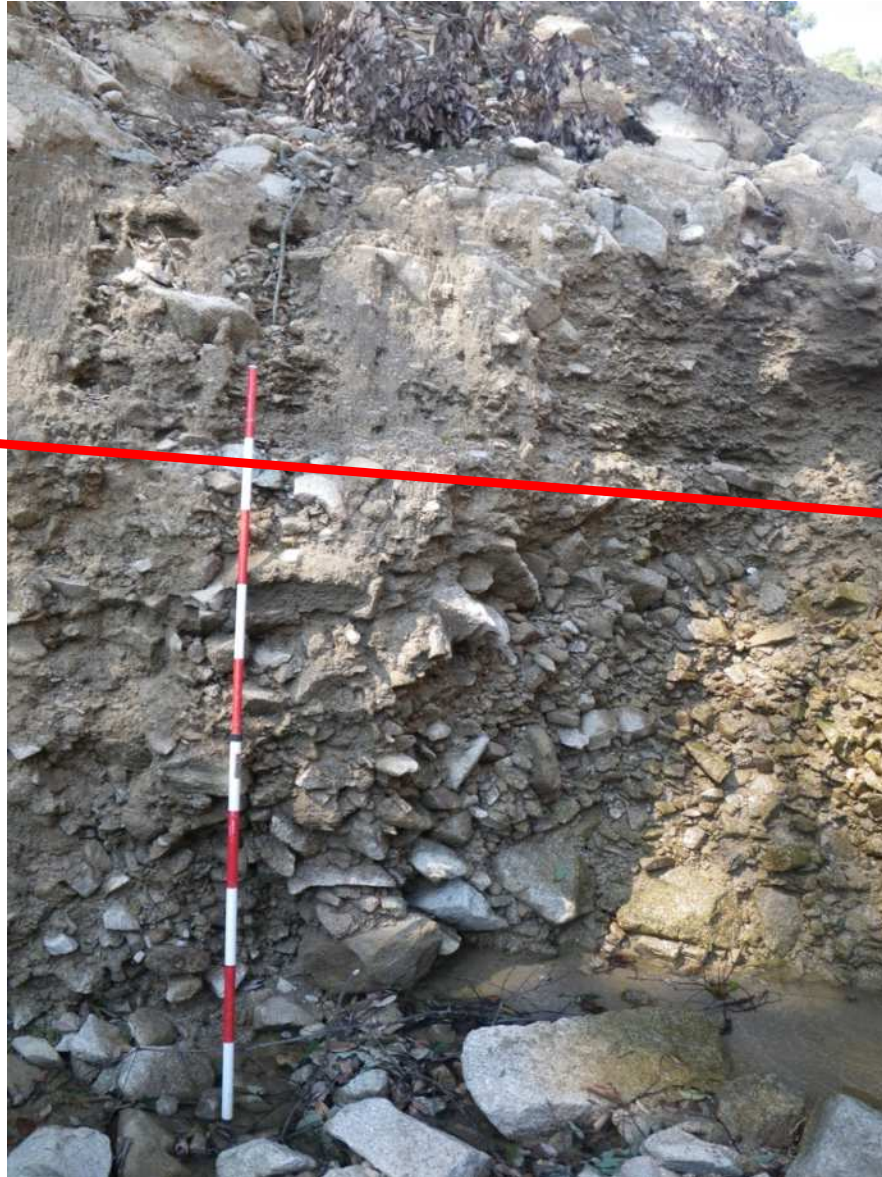
# Out crop of the debris flow sediments

layer③ Parallel structure

Upper:Debrisflow sediments

Lower:Medium sand-silt layer

boundary

layer② Irregular structure

Cobble size gravel

Debrisflow sediments

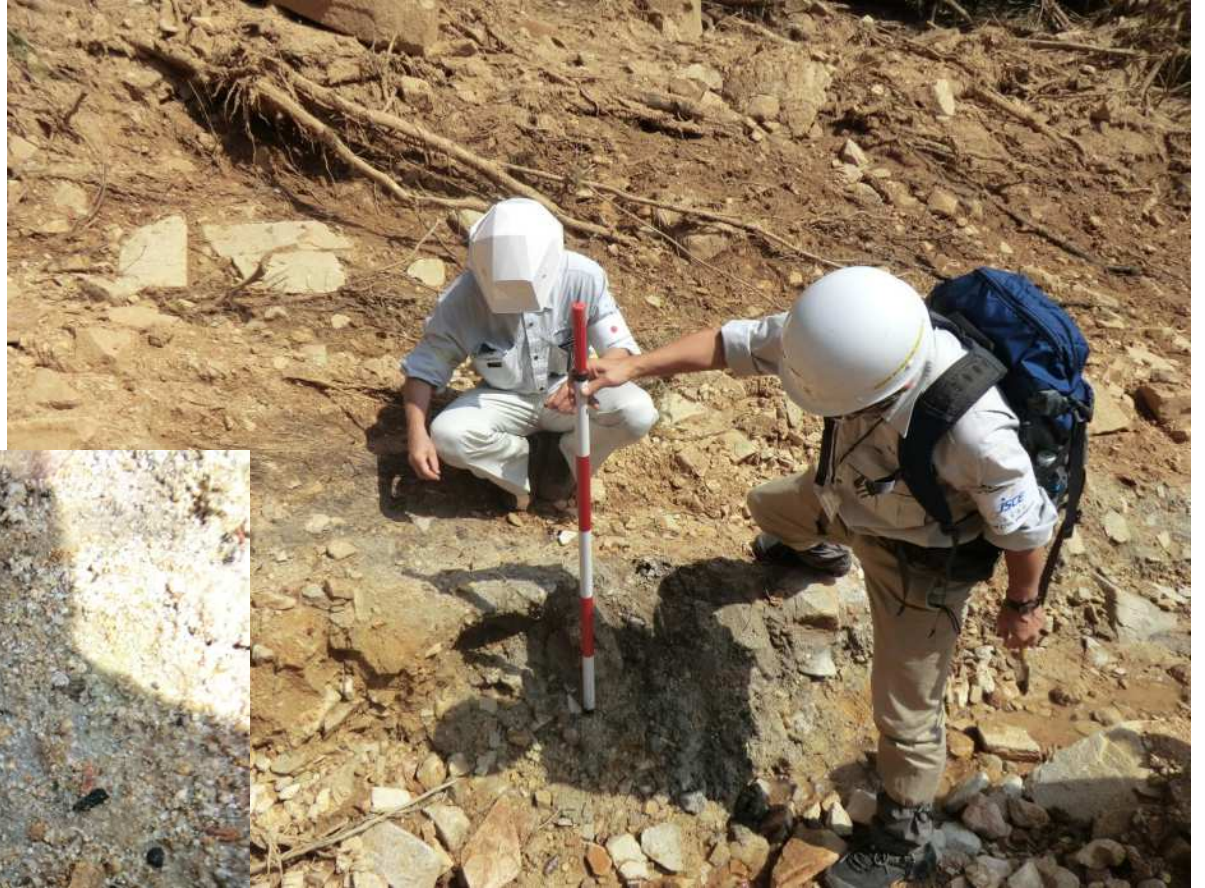
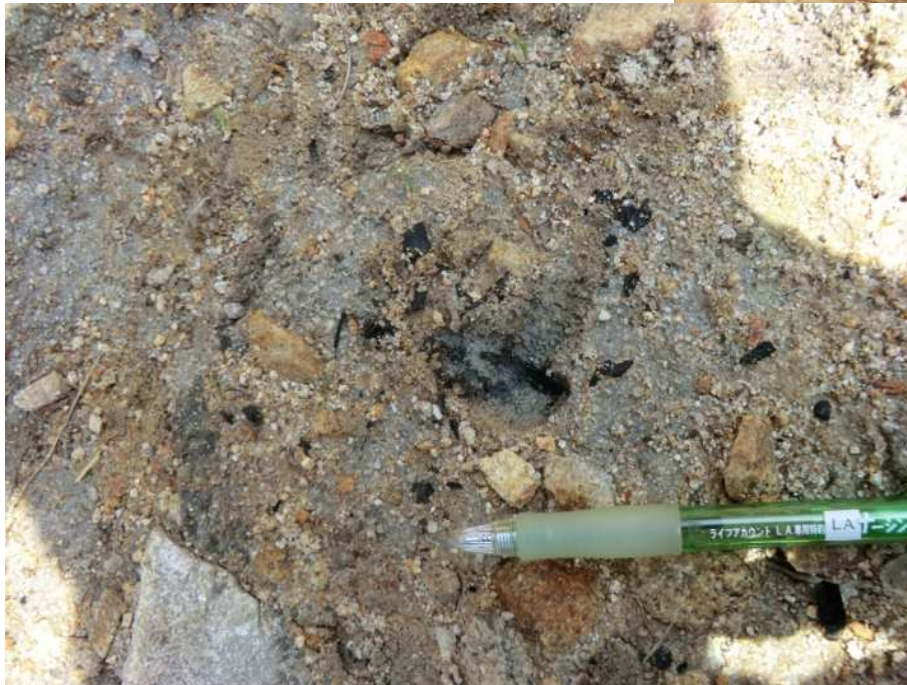
# Field survey and carbon sample

Radiocarbon dating( $^{14}\text{C}$ )  
from the debris flow  
deposits

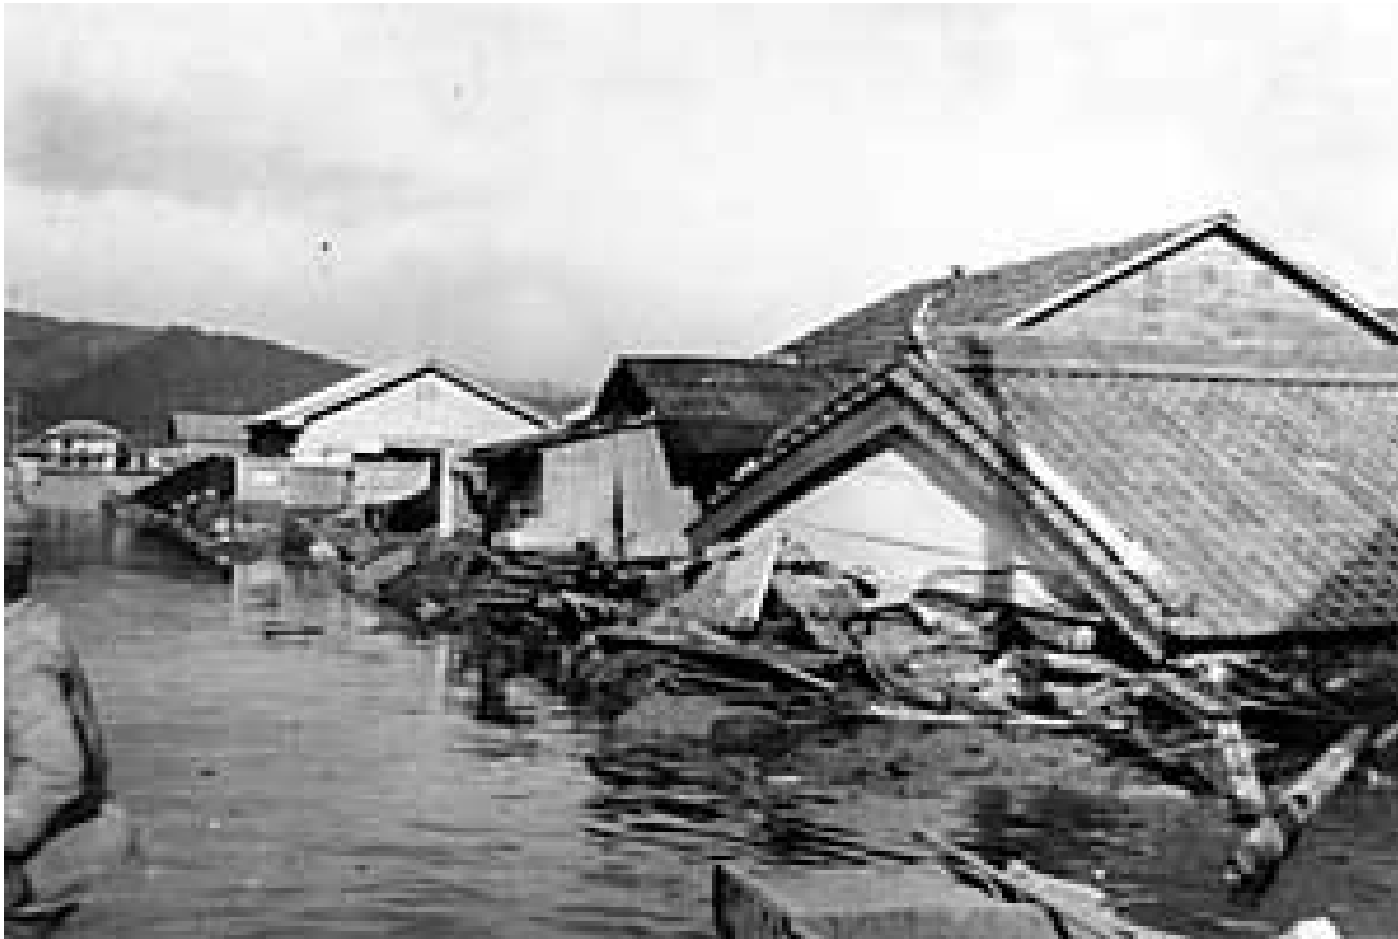
**Flood and damage of house**  
**Nankai earthquake Kochi city**  
**Dec. 21, 1946** (1,400 dead and missing)
